# NPS INVENTORY

Lake George Patrol Cabin

Lake George N-107

NPS/Mount Rainier National Park, Tahoma Woods-Star Route, Ashford, Washington

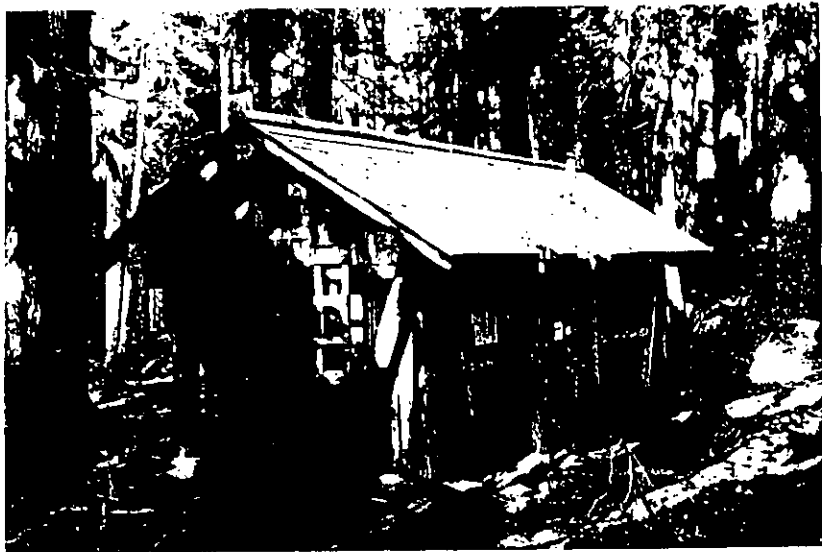
17. PHOTOS AND SKETCH MAP OF LOCATION

Wood-frame, one-story, two-room, rectangular cabin; medium-pitched cedar shake gable roof; stove pipe on front gable slope; log rafters with whittled ends; projecting eaves and verges; log ridge beam; two gable length support beams (purlins); exterior walls are log post and beam and 1 x 12 vertical board; vertical board and batten at gable ends; no corner notching; small windows with outside screens and bars; 1 x 7 vertical board hinged door; unfinished interior; wood floor; log on concrete pier foundation.

The present patrol cabin at Lake George was constructed by the National Park Service in 1934. Measuring 12' x 26.5', with a floor size of 287 square feet, the cabin was intended to be a horse barn. It was divided into a horse stall and grainery. Shortly after its construction, it was converted into a ranger patrol cabin, consisting of a living

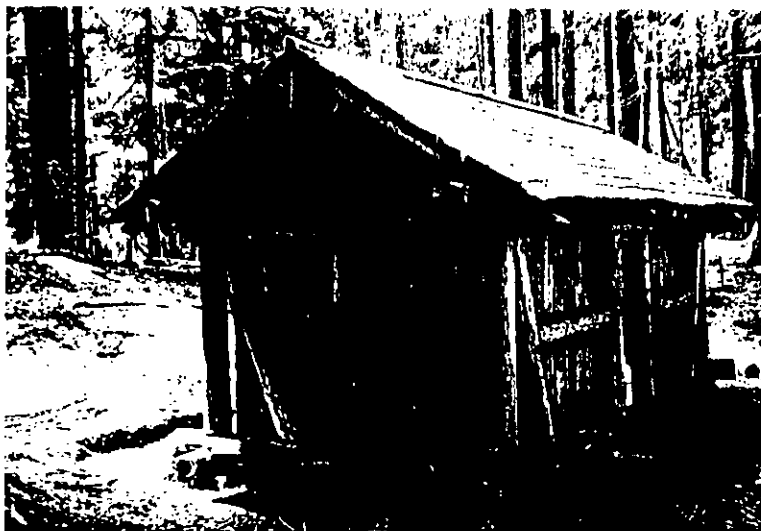
17. PHOTOS AND SKETCH MAP OF LOCATION

Present condition of the cabin is fair. Rot was observed on the front facade log sills.
